FIRE ENDURANCE TESTS OF EXTERIOR WALL AND ROOF/CEILING CONSTRUCTIONS FOR SINGLE FAMILY HOUSE

NBS REPORT

10 406

Prepared for:
Department of Housing and Urban Development

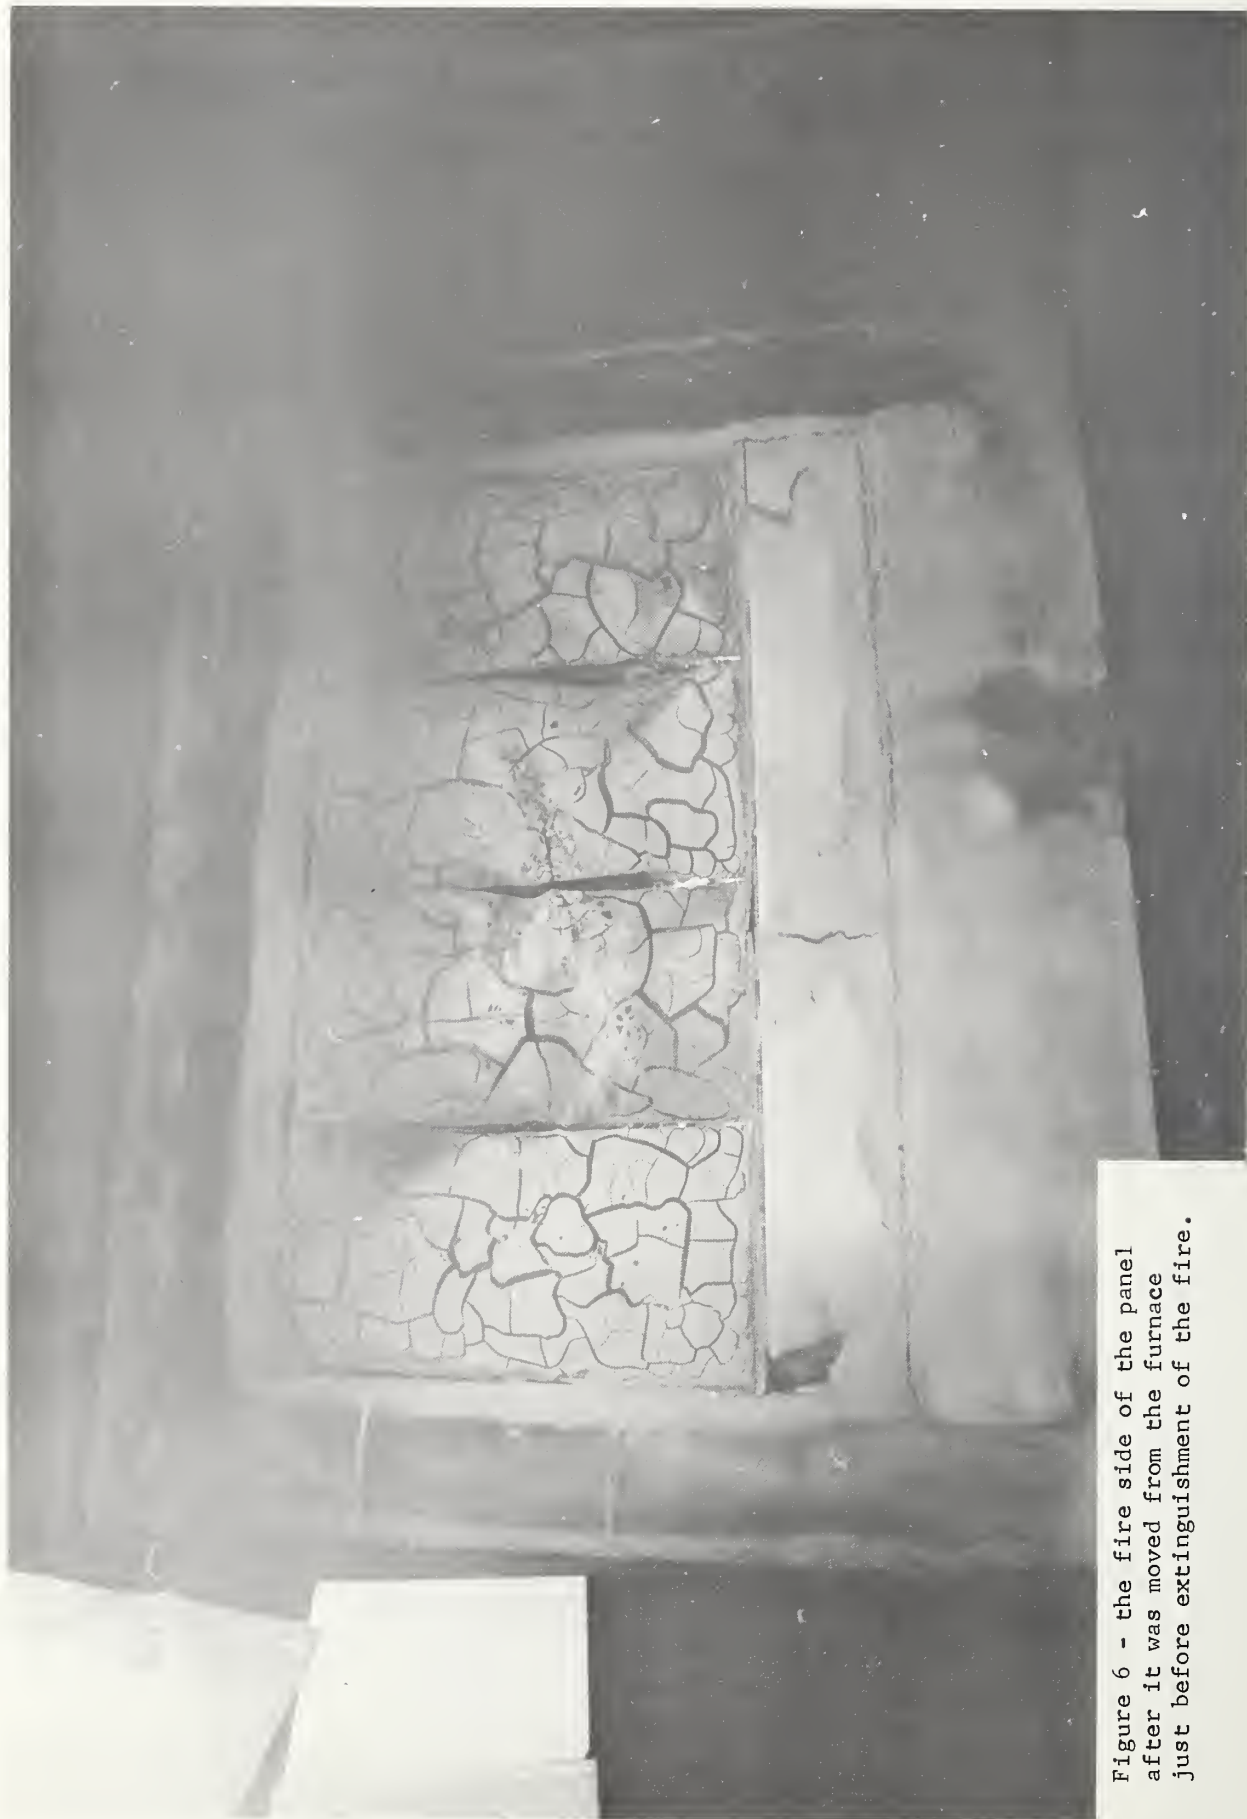
The average and maximum temperature rise of the unexposed surface and temperature gradient across the panel are shown in Figures 4 and 5, respectively. Figure 6 is a photograph showing the fire side of the panel after it was removed from the furnace just before extinguishment of the fire. Surfaces were buckled and the paint surfaces were blistered. Most of wood members, paper honeycomb and polyurethane foam were consumed during the 27 minutes of the test.

Figure 6 - the fire side of the panel after it was moved from the furnace just before extinguishment of the fire.

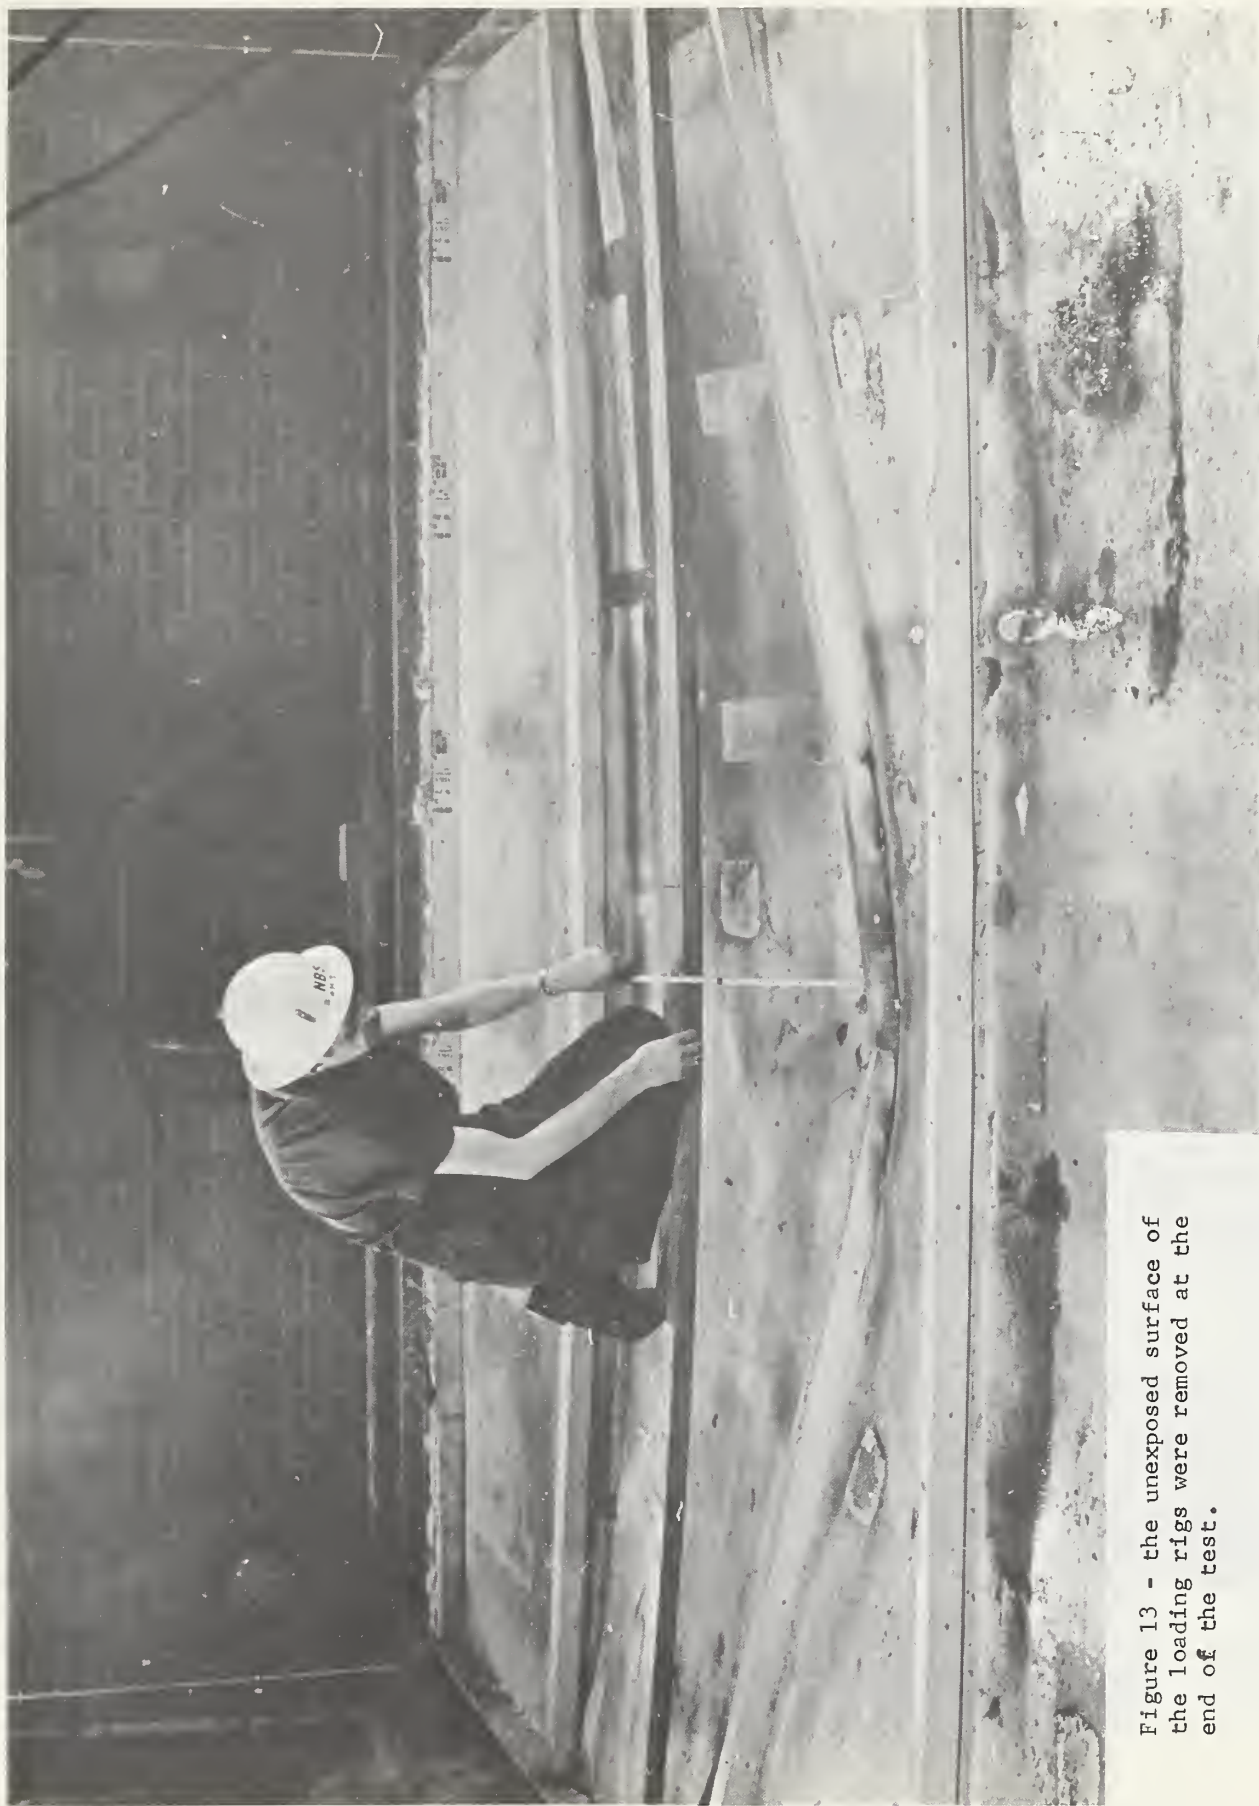
The photographs in figures 13 and 14 show the unexposed surface of the panel after the loading rigs were removed at the end of the test and the exposed surface at the failed joint. Most of the wood members and polyurethane foam were consumed except a few pieces around edges of the assembly. The paper honeycomb seemed to keep its shape, but it charred and delaminated from the bottom surface as shown in figure 15.

Figure 13 - the unexposed surface of the loading rigs were removed at the end of the test.

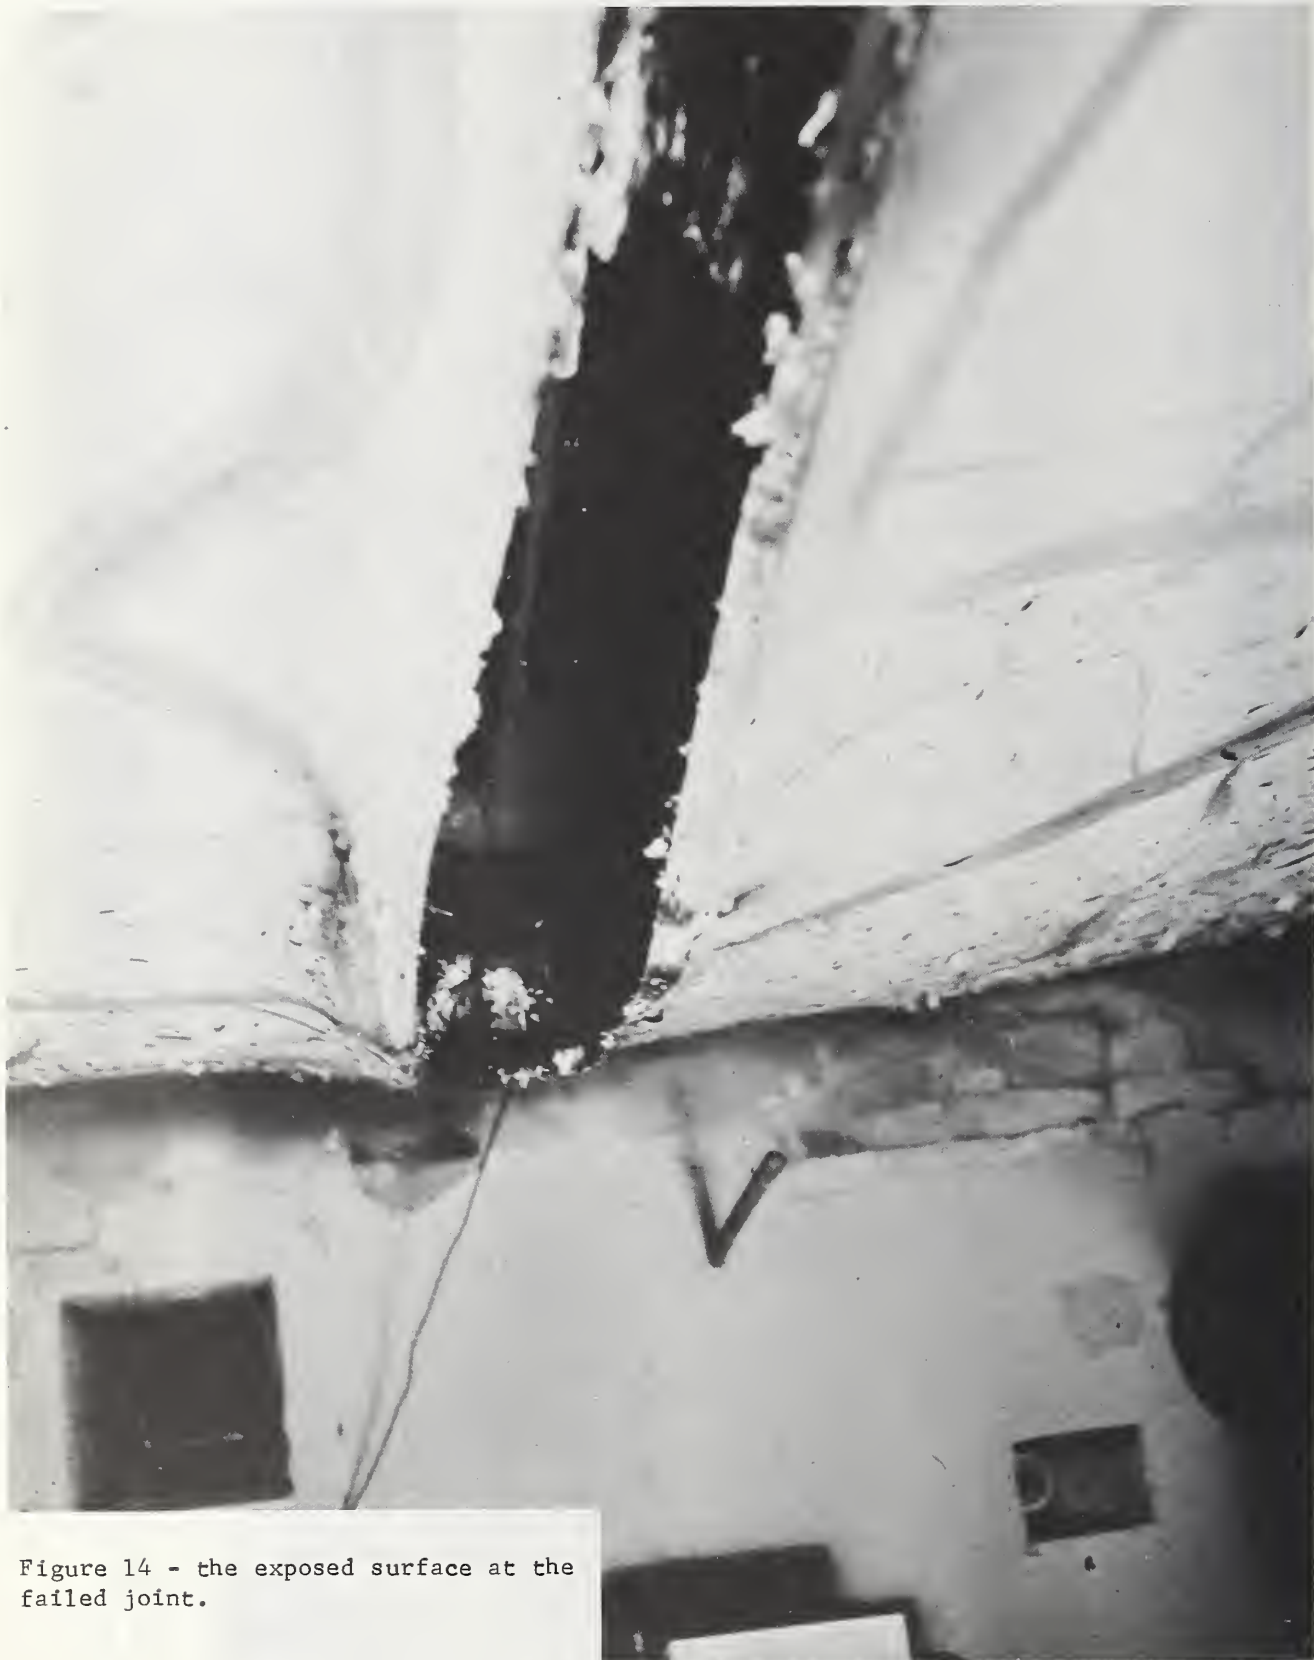
Figure 14 - the exposed surface at the failed joint.

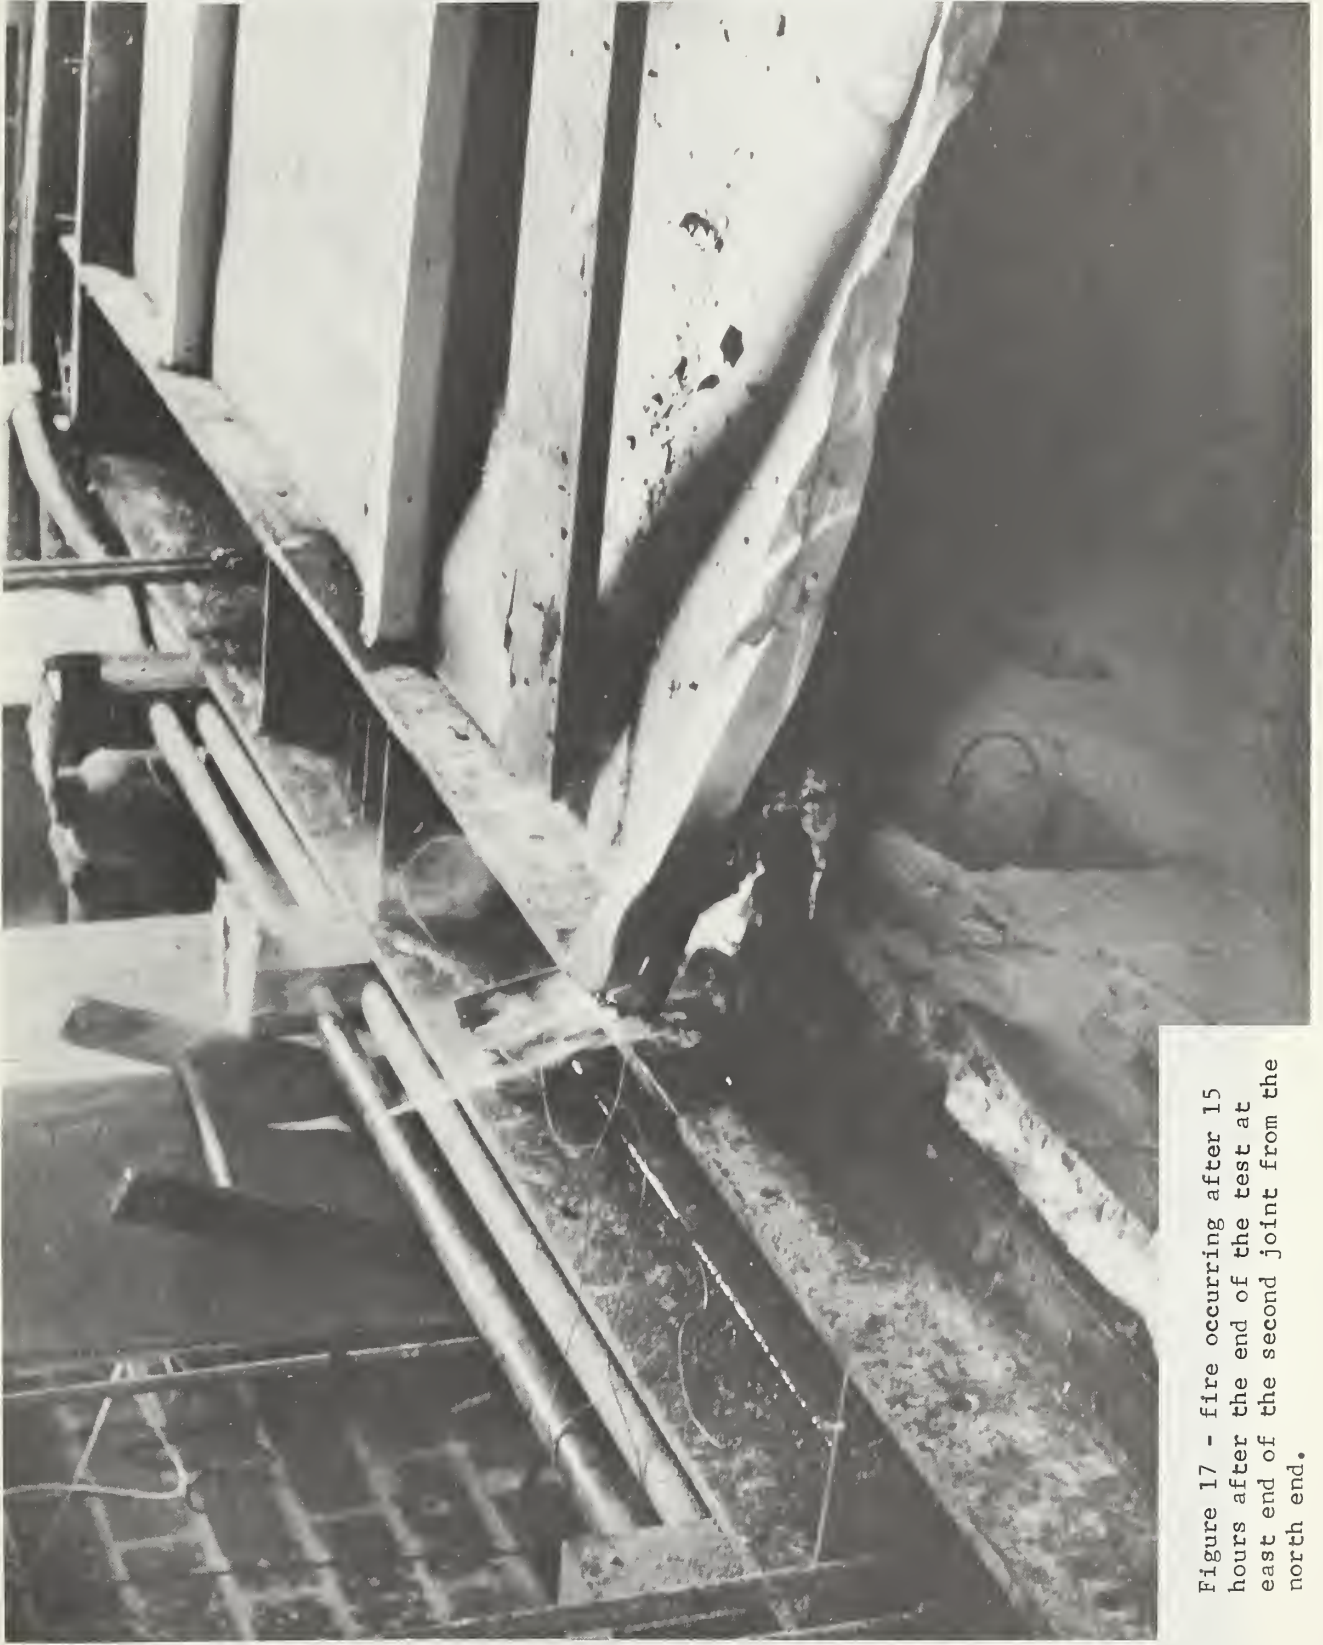
It was not necessary to apply fog nozzle on to the specimen to extinguish the flames at the end of the test, because the fire appeared to go out quite well. However, smoke was observed the next morning, about 12 hours after completion of the test. All joints on the exposed surface had opened up and the failed joint showed the maximum opening of 4-1/4 inch (figure 14) compared with 11/16 inch (figure 16) before the test. Fifteen hours after the end of the test the specimen burst into flame when it was being dismantled at east end of the second joint from the north end. The height of the flame was approximately 2 ft. (See figure 17).

* Fifteen hours after the end of test the specimen burst into flame when it was dismantled at east end of the second joint from the north end. The height of flame was approximately 3 ft (See figure 17).

Figure 17 - fire occurring after 15 hours after the end of the test at east end of the second joint from the north end.
